**COMPREHENSIVE**  
PROPERTY INSPECTIONS

**Address Inspected: 999 E Snow Ln, Tempe, AZ 85118**

**Date of Inspection: 4/1/2026**

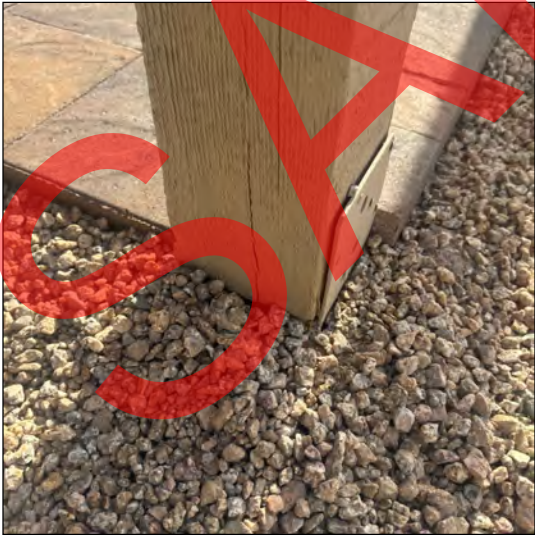
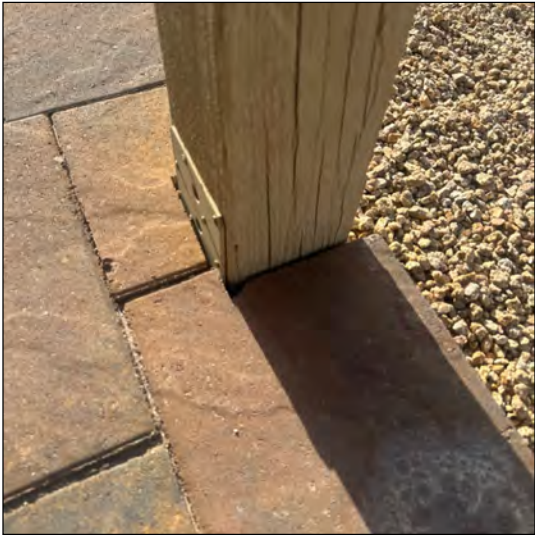
| Grounds | | | |
|---|---|---|---|
| The rear cover columns lacked proper clearances to surrounded pavers and elevated landscaping (grade). Moisture damage may result from this direct contact. Upgrades or corrections are advised (with ongoing monitoring recommended). | | The rear cover columns lacked proper clearances to surrounded pavers and elevated landscaping (grade). Moisture damage may result from this direct contact. Upgrades or corrections are advised (with ongoing monitoring recommended). | |

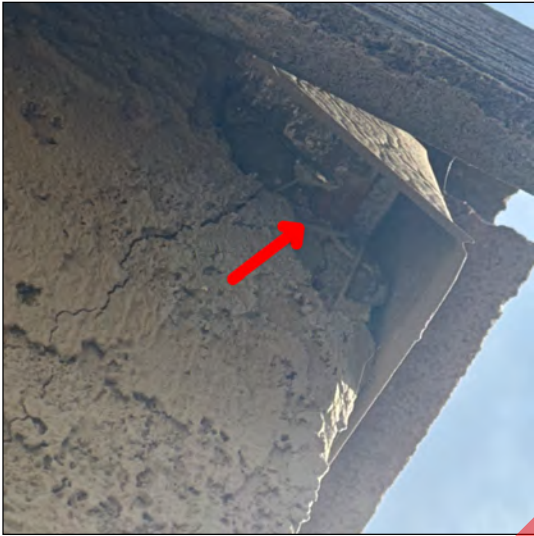
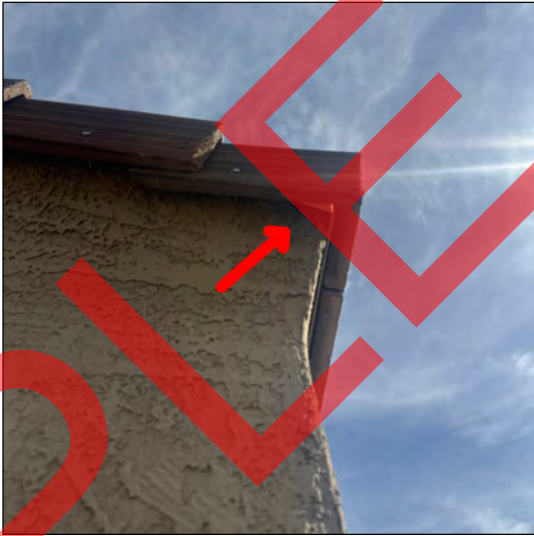
| <div></div> <p>Incomplete or damaged stucco noted at the rear southeast upper corner (improperly exposing internal building components). While the above flashing and roof covering may add some moisture protection, <b>professional</b> repairs are recommended to prevent moisture and pest entry vulnerability.</p> <p>Incomplete or damaged stucco noted at the rear southeast upper corner (improperly exposing internal building components). While the above flashing and roof covering may add some moisture protection, <b>professional</b> repairs are recommended to prevent moisture and pest entry vulnerability.</p> | | | |

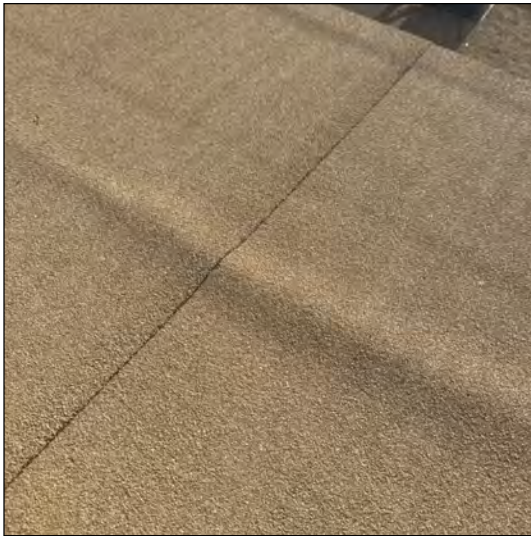
Areas of premature, buckling and lift lifted edges noted at the rear roll roof cover covering. Further evaluation by a **licensed** roofing **professional** is recommended with repairs as needed to ensure proper water tightness and drainage.

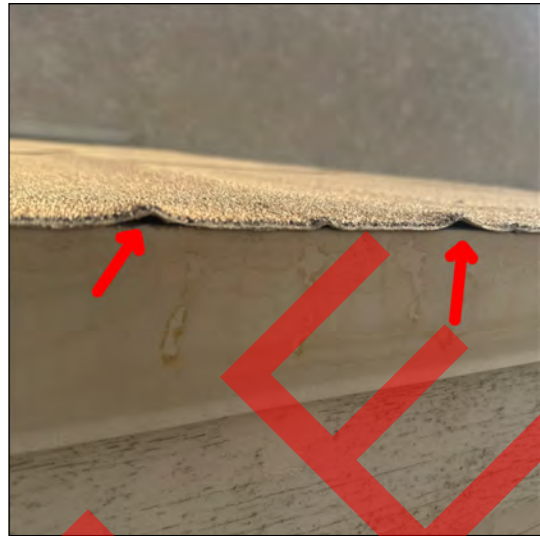
Areas of premature, buckling and lift lifted edges noted at the rear roll roof cover covering. Further evaluation by a **licensed** roofing **professional** is recommended with repairs as needed to ensure proper water tightness and drainage.

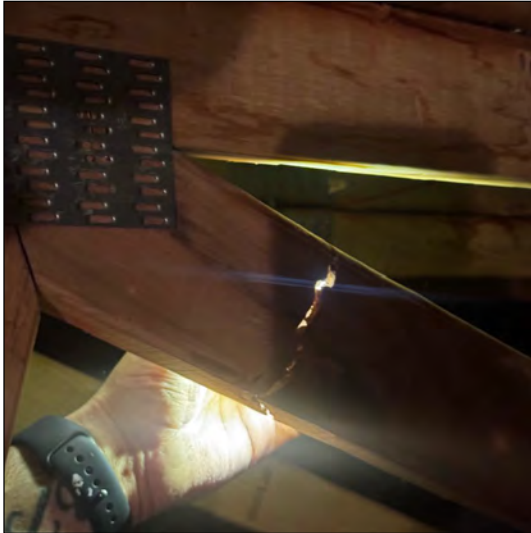
Cracked **truss** member near air handler platform.  
PHOTO A

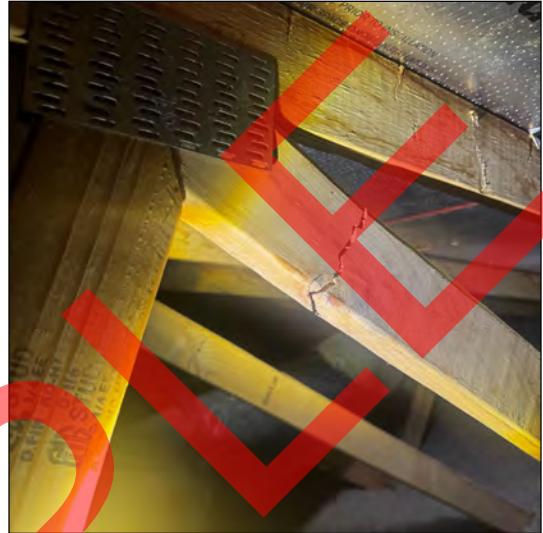
Cracked **truss** member near air handler platform.  
PHOTO B

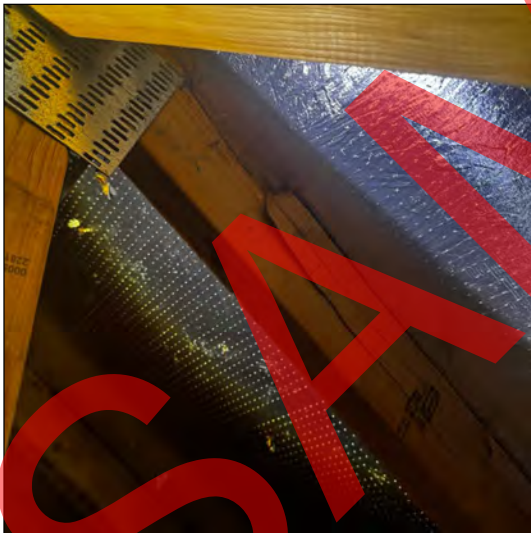
Cracked **truss** member near garage attic access entrance. PHOTO A

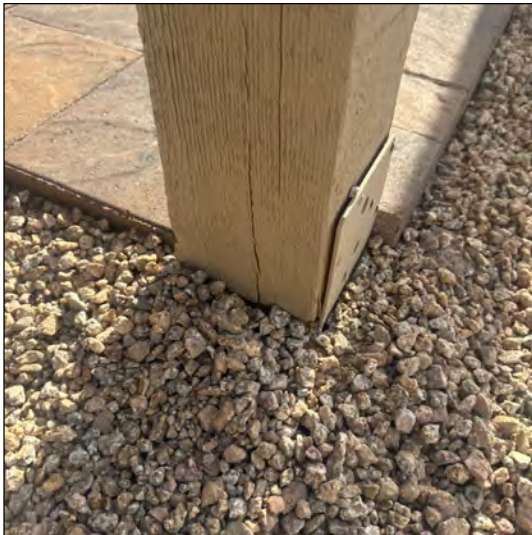
5.1. The rear cover columns lacked proper clearances to surrounded pavers and elevated landscaping (**grade**). Moisture damage may result from this direct contact. Upgrades or corrections are advised (with ongoing monitoring recommended).

The rear cover columns lacked proper clearances to surrounded pavers and elevated landscaping (**grade**). Moisture damage may result from this direct contact. Upgrades or corrections are advised (with ongoing monitoring recommended).

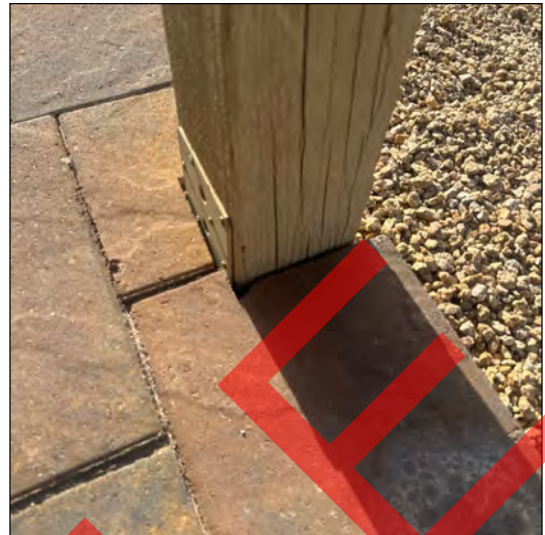
The rear cover columns lacked proper clearances to surrounded pavers and elevated landscaping (**grade**). Moisture damage may result from this direct contact. Upgrades or corrections are advised (with ongoing monitoring recommended).

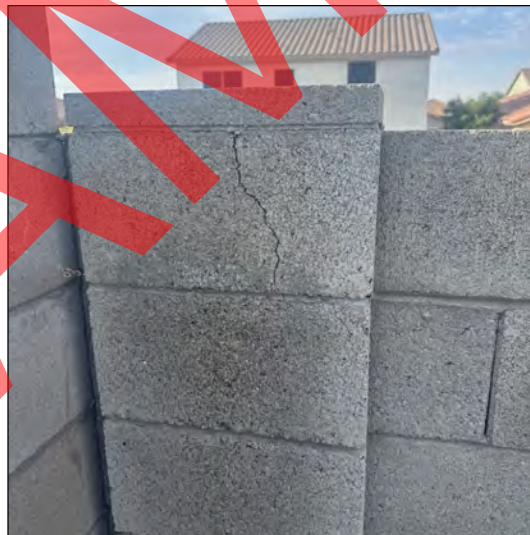
6.1. Minor cracks were found at the rear surrounding block fence walls. Recommend maintenance repairs and ongoing monitoring.

Minor cracks were found at the rear surrounding block fence walls. Recommend maintenance repairs and ongoing monitoring.

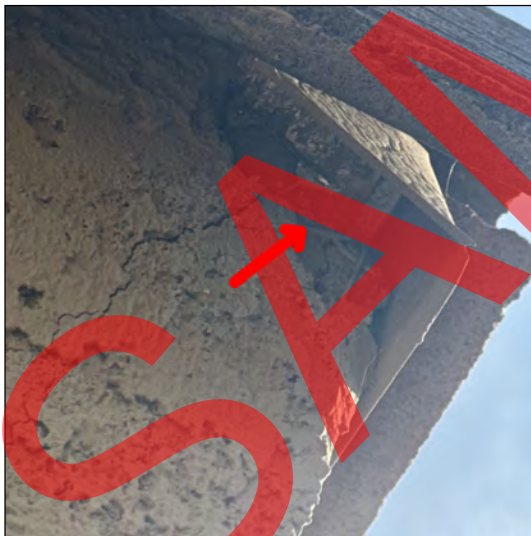
2.1. Incomplete or damaged stucco noted at the rear southeast upper corner (improperly exposing internal building components). While the above flashing and roof covering may add some moisture protection, **professional** repairs are recommended to prevent moisture and pest entry vulnerability.

Incomplete or damaged stucco noted at the rear southeast upper corner (improperly exposing internal building components). While the above flashing and roof covering may add some moisture protection, **professional** repairs are recommended to prevent moisture and pest entry vulnerability.

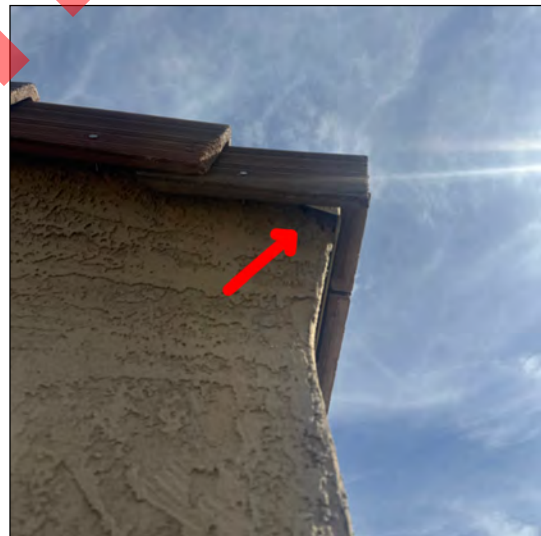
Incomplete or damaged stucco noted at the rear southeast upper corner (improperly exposing internal building components). While the above flashing and roof covering may add some moisture protection, **professional** repairs are recommended to prevent moisture and pest entry vulnerability.

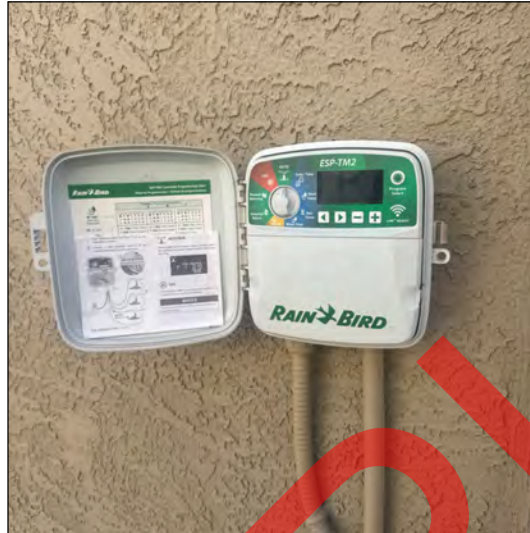
**TIMER LOCATION:** Front side exterior wall

Sprinkler control valves and electrical connections to the timer have been inspected. Full irrigation inspection of all sprinklers, drip heads and zones were not performed.

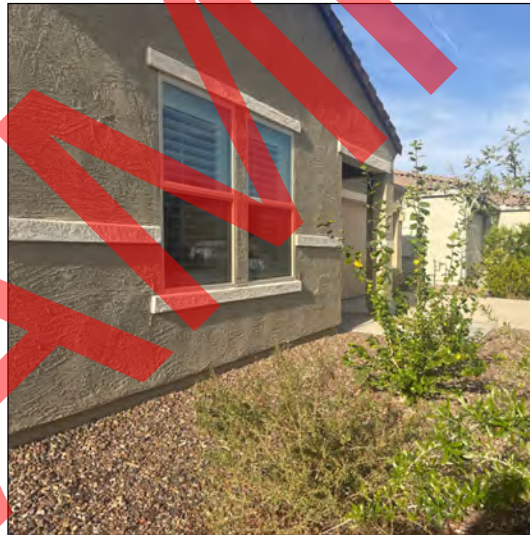
2.1. Trees/vegetation was planted close to the structure. These areas of vegetation may need to be removed or trimmed (regularly) to prevent damage to the foundation, exterior walls and/or roofing materials.

Trees/vegetation was planted close to the structure. These areas of vegetation may need to be removed or trimmed (regularly) to prevent damage to the foundation, exterior walls and/or roofing materials.

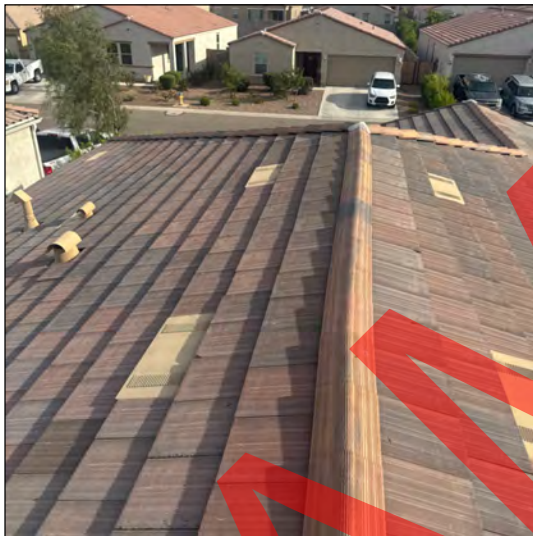
TYPE: Concrete Tile

General Roof Surface Photos

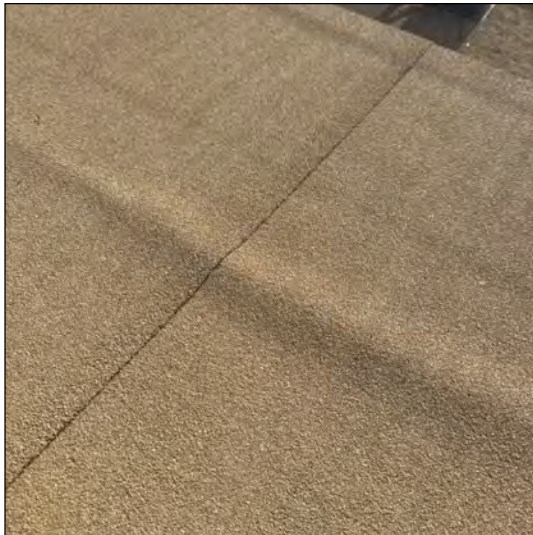
2.1. Areas of premature, buckling and lift lifted edges noted at the rear roll roof cover covering. Further evaluation by a **licensed** roofing **professional** is recommended with repairs as needed to ensure proper water tightness and drainage.

Areas of premature, buckling and lift lifted edges noted at the rear roll roof cover covering. Further evaluation by a **licensed** roofing **professiona** is recommended with repairs as needed to ensure proper water tightness and drainage.

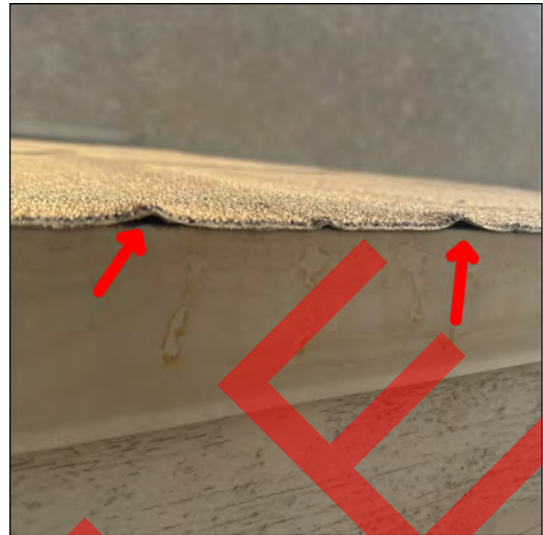
Areas of premature, buckling and lift lifted edges noted at the rear roll roof cover covering. Further evaluation by a **licensed** roofing **professiona** is recommended with repairs as needed to ensure proper water tightness and drainage.

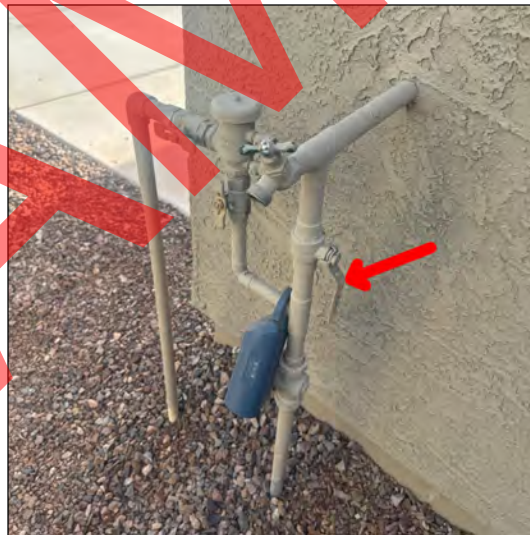
**LOCATION:** Front exterior wall

The main plumbing shut off valve was observed at the exterior wall.

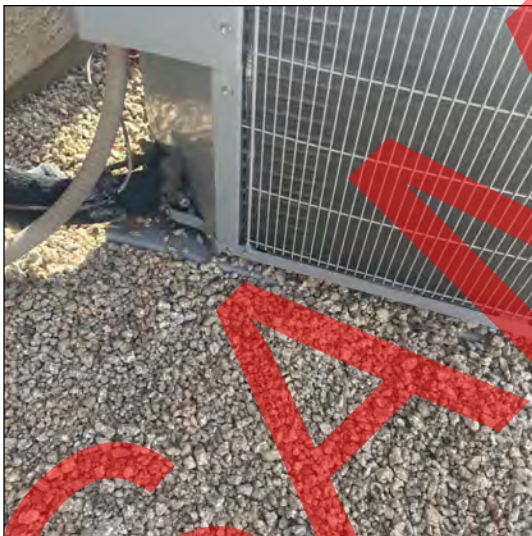
1.1. Improper soil/landscaping height surrounding the rear exterior AC condenser equipment. Recommend corrections to prevent potential moisture/soil related concerns including drainage defects.

Improper soil/landscaping height surrounding the rear exterior AC condenser equipment. Recommend corrections to prevent potential moisture/soil related concerns including drainage defects.

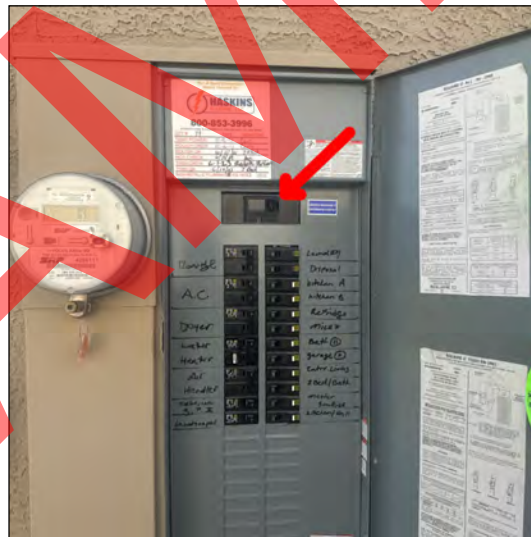
**MAIN PANEL LOCATION:** The front exterior wall

The main electric panel was located at the exterior wall, containing the 200 amp electrical disconnect.

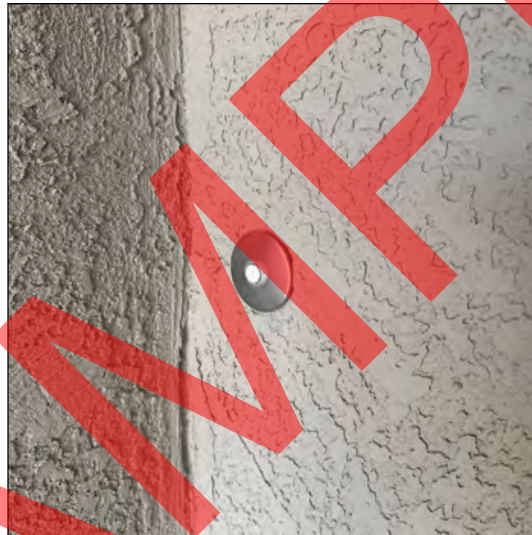
1.1. While testing properly operational, the front entry doorbell hardware appeared to be loose to the exterior wall.

While testing properly operational, the front entry doorbell hardware appeared to be loose to the exterior wall.

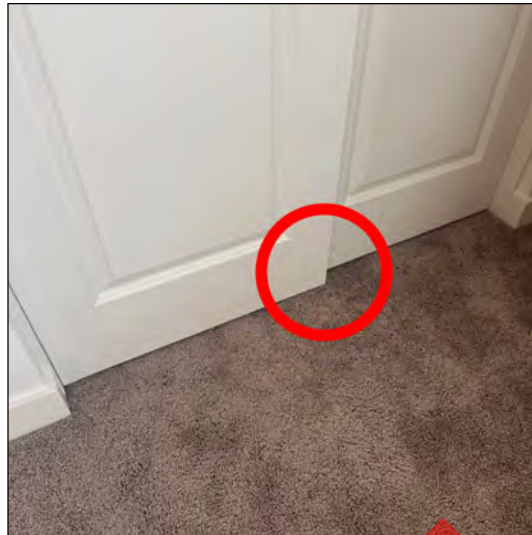
2.1. Bedroom interior closet doors were missing bottom tracks. Recommend corrections to minimize potential damage and ensure proper operation.

Bedroom interior closet doors were missing bottom tracks. Recommend corrections to minimize potential damage and ensure proper operation.

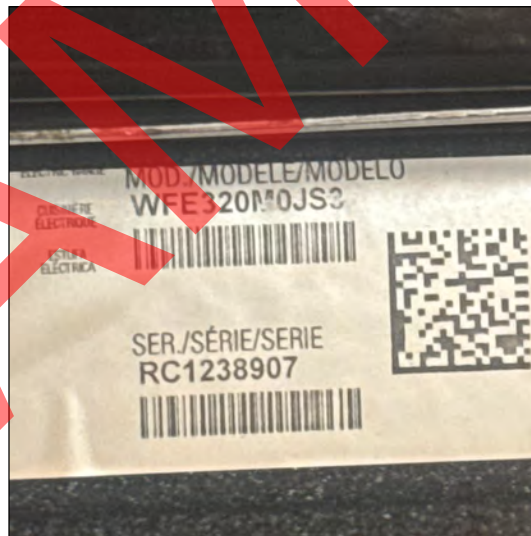
OVEN MANUFACTURE LABEL

TYPE: Electric

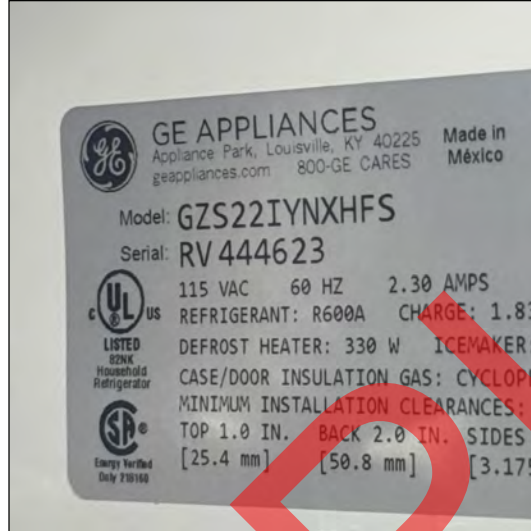
13.1. Though no full test was performed on the kitchen refrigerator and a connected waterline was found behind the appliance, no ice was present/generated during the time of the inspection. Further investigation is advised to determine functionality.

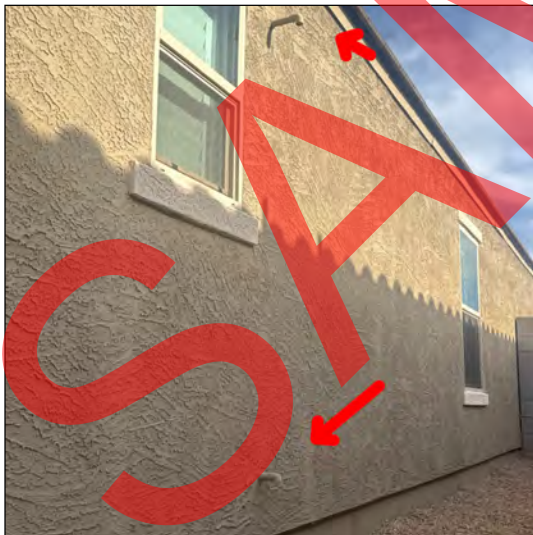
Condensation lines should be monitored on a regular basis for blockage. Blocked condensation lines may lead to moisture damage near and below air handler units.

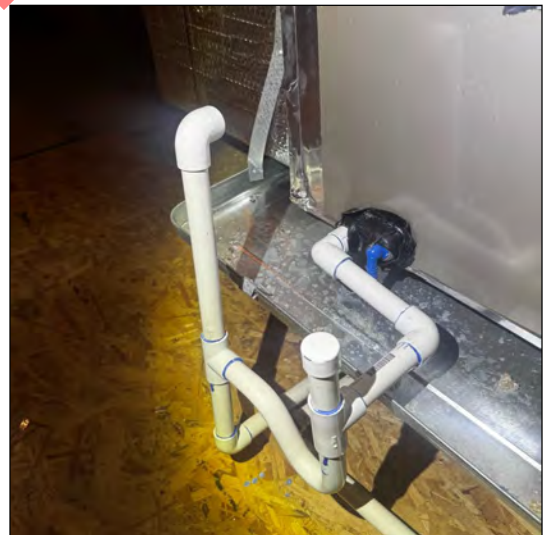
Condensation lines should be monitored on a regular basis for blockage. Blocked condensation lines may lead to moisture damage near and below air handler units.

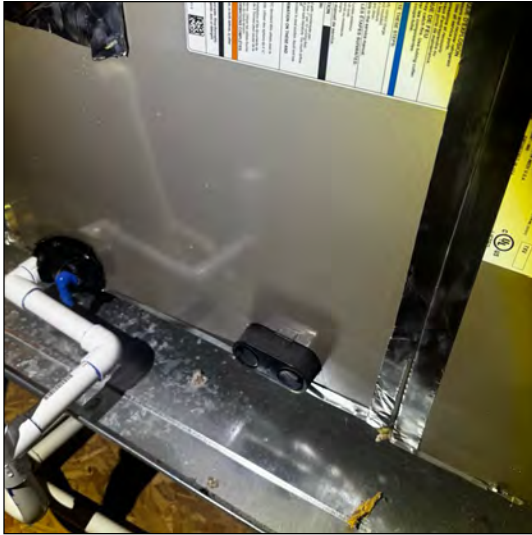
Unable to inspect coils or interior components as the unit was sealed at the time of the inspection. Ongoing monitoring and regular servicing is recommended to ensure proper and efficient functionality.

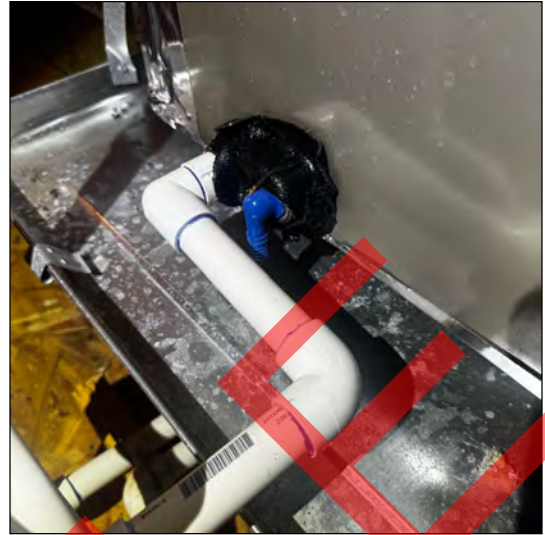
Recommend adding a "Safe-T" switch device to the condensation drain line, or below catch pan, to help identify blocked condensation lines and prevent potential related damages.

1.3. Recommend adding a "Safe-T" switch device to the condensation drain line, or below catch pan, to help identify blocked condensation lines and prevent potential related damages.

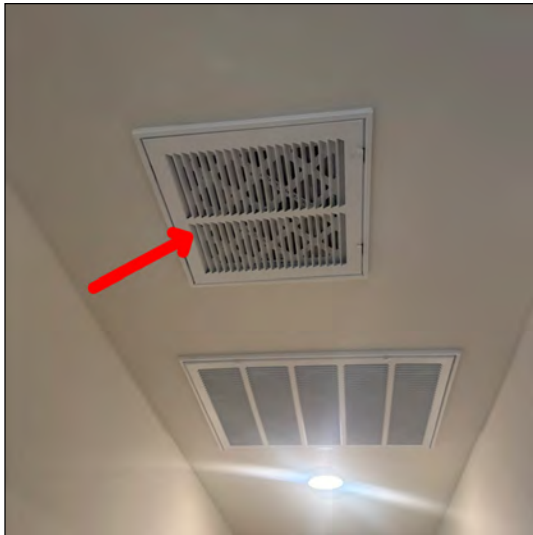
Recommend changing all air filters on a regular basis for better HVAC operation and ensure proper air flow. Filter replacements include the fresh air vent filter (that may only appear dirty from the interior facing side).

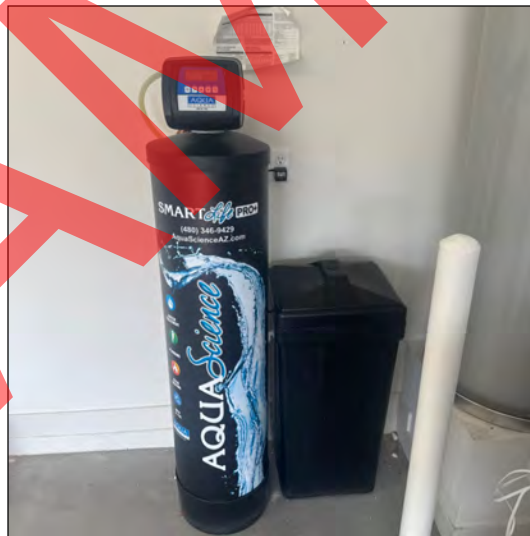
No full test or inspection performed on the present water softener equipment (outside the scope of the inspection). Further investigation or inspection by a qualified plumbing **professional** may be needed or desired.

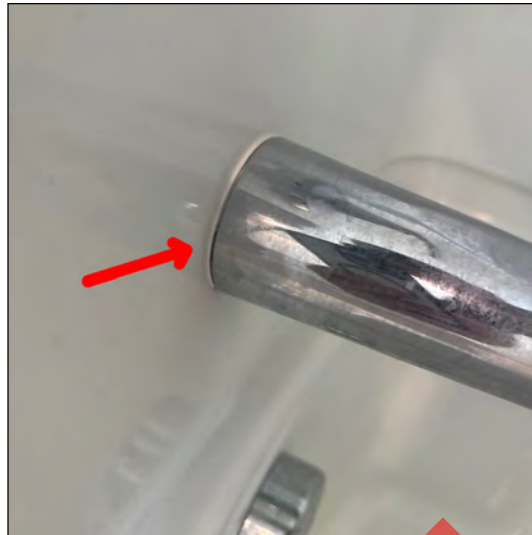
5.1. Separations observed in the primary bathroom tub spout and enclosure finish walls. Recommend proper repairs to prevent moisture entry and minimize potential damage.

Separations observed in the primary bathroom tub spout and enclosure finish walls. Recommend proper repairs to prevent moisture entry and minimize potential damage.

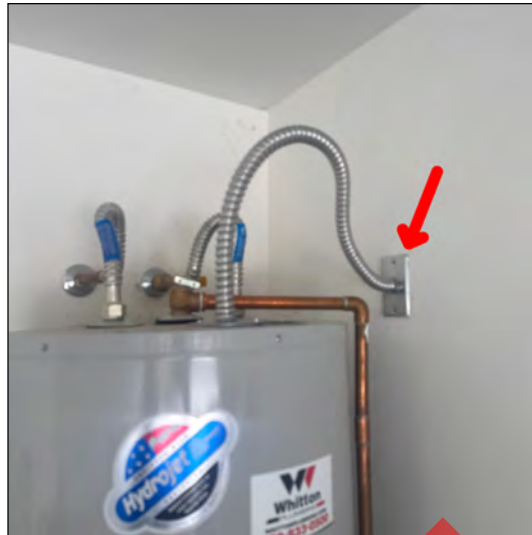
Recommend adding an electrical disconnect (breaker, fuse, light switch, etc) at the wall electrical juncture for safety enhancements (allowing emergency shut off if ever needed).

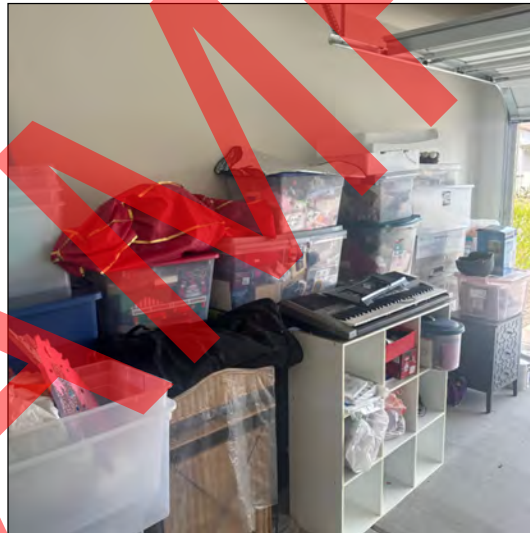
The garage walls were not fully visible due to the occupants belongings and storage.

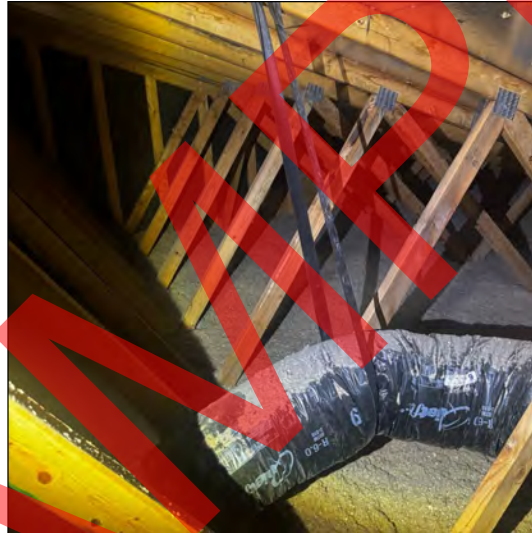
- ✓ • Limited inspection performed with attic space due to access design, insulation type and duct work layout. Regular **professional** inspection is advised to ensure no damages or leaking is present with repairs as needed.

Entered the accessible attic space.

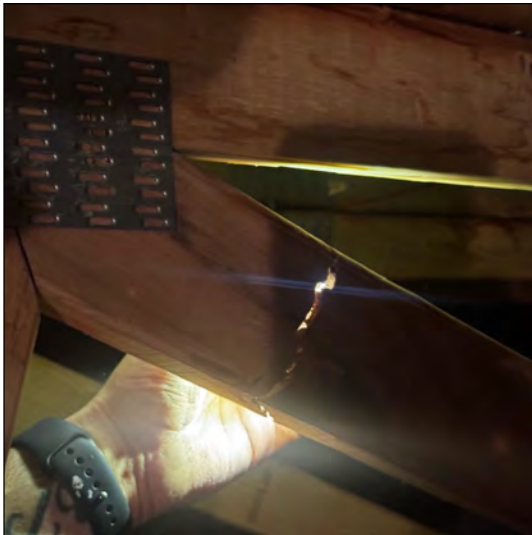
Cracked **truss** member near air handler platform.  
PHOTO A

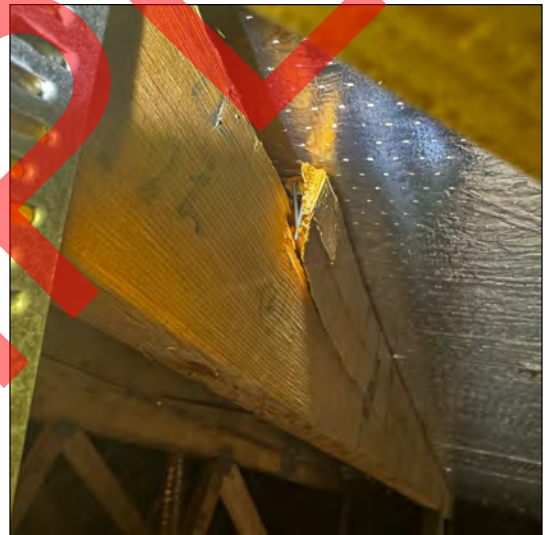
Cracked **truss** member near garage attic access  
entrance. PHOTO B

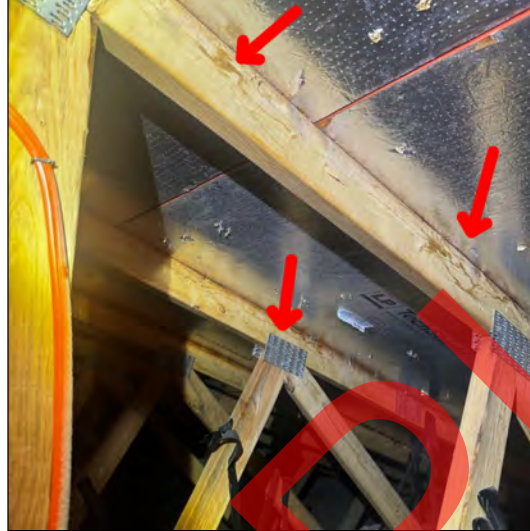
Minor moisture stains were observed throughout the attic space - discoloration patterns and widespread exposure indicate staining during or prior to construction. Ongoing roofing inspection and **professiona** maintenance/repairs are recommended.

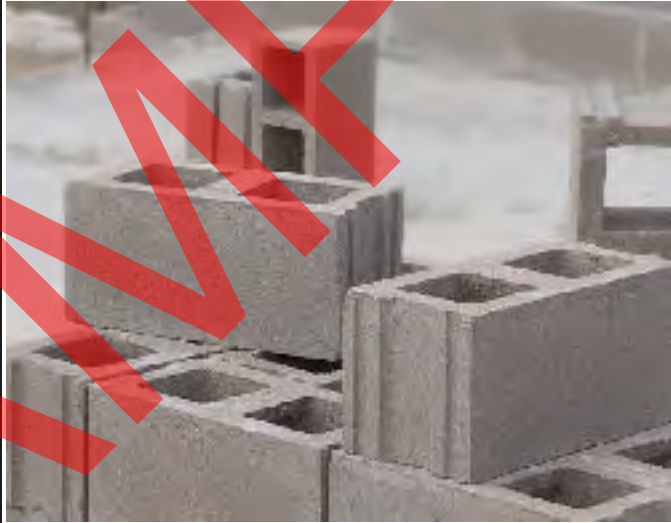
| Term | Definition |
|---|---|
| CMU | <p>CMU stands for "Concrete Masonry Unit", which is a rectangular or square block made of concrete used in construction. CMUs are a common building material used to construct walls and exterior fences.</p> |
